# UNDERWATER BRIDGE INSPECTION REPORT

STRUCTURE NO. 01506  
CSAH NO. 1  
OVER THE  
MISSISSIPPI RIVER  
DISTRICT 3 - AITKIN COUNTY

PREPARED FOR THE  
MINNESOTA DEPARTMENT OF TRANSPORTATION  
BY  
COLLINS ENGINEERS, INC.  
JOB NO. 3512 (CEI 68)

MINNESOTA DEPARTMENT OF TRANSPORTATION  
UNDERWATER BRIDGE INSPECTION

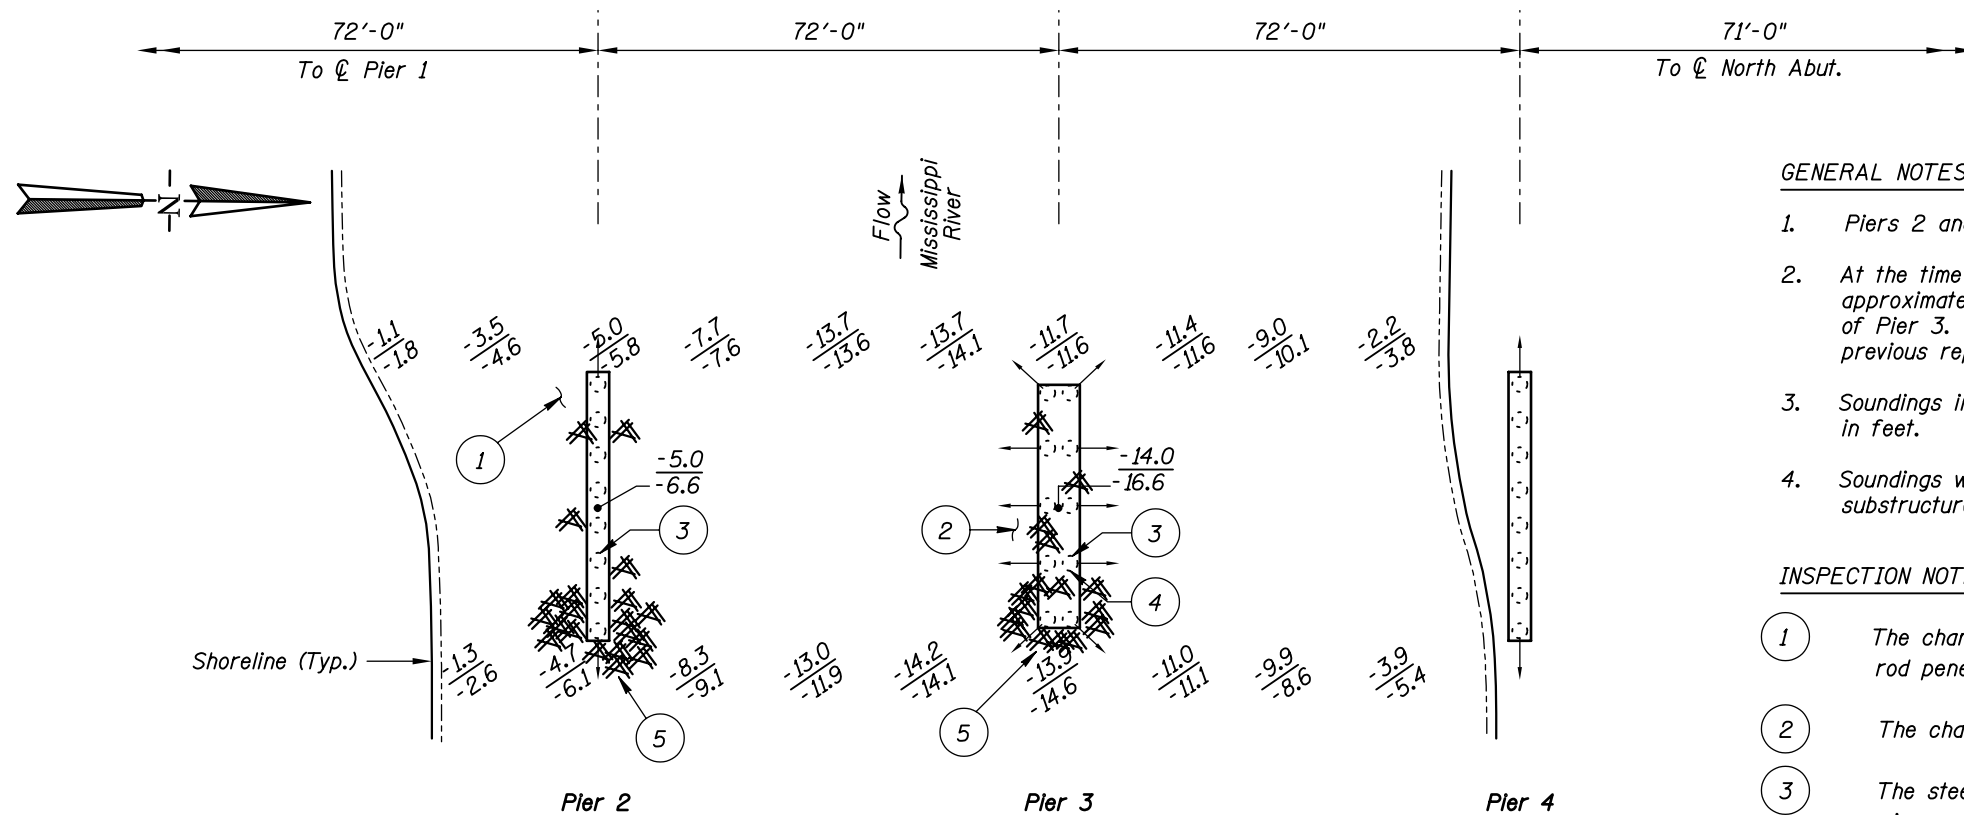
#### INSPECTION AND SOUNDING PLAN

- The channel bottom consisted of silty sand with 6 to 8 inches of probe rod penetration.
- The channel bottom consisted of gravely sand with 4 inches of probe rod penetration.
- The steel pipe piles exhibited 100 percent coating failure with light corrosion and minor rust nodules with up to 1/8 inch of pitting (1/8 inch typical) over 50 percent of the surface area from 6 feet above the waterline to the channel bottom.
- The steel pipe piles at Pier 3 exhibited 1/16 inch surface delamination due to corrosion from 3 below the waterline to the channel bottom.
- A heavy accumulation of timber debris, consisting of 4-inch to 2-foot-diameter logs and branches, was observed at the upstream end and throughout the piles from the channel bottom to the waterline.

- (A) Remove timber debris from around the piles at Piers 2 and 3 during routine bridge maintenance, to eliminate excessive lateral loads on piers and the potential for scour.

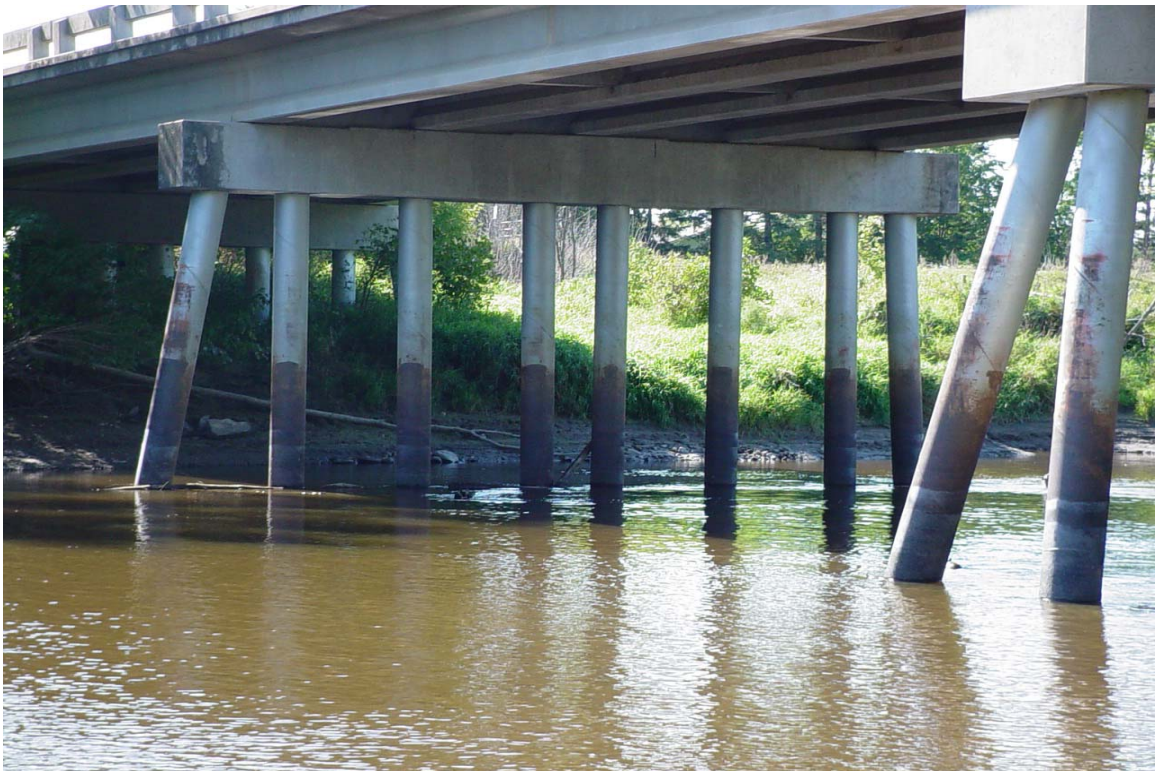
Photograph 2. View of Pier 2, Looking Southwest.

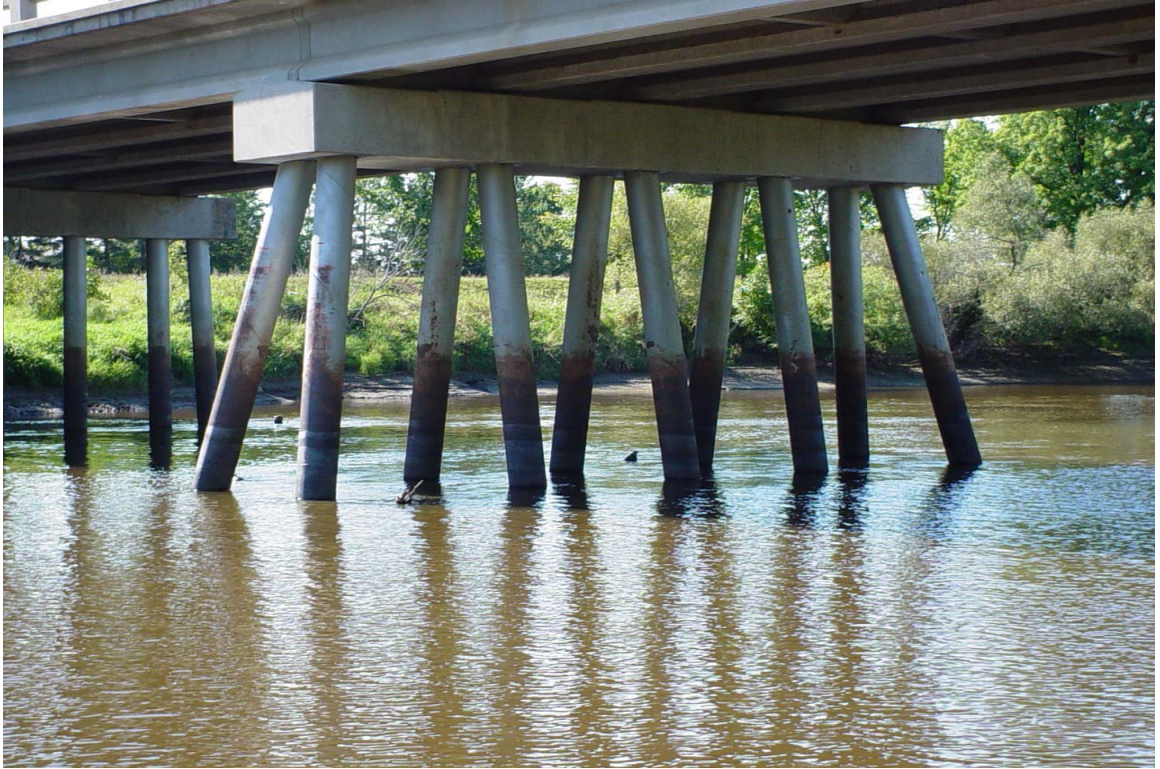
Photograph 3. View of Pier 3, Looking Southwest.
